American Buildings & Bridges Continue to Age & Deteriorate

By Jasper Calcara, P.E., President of D.H. Charles Engineering Inc.,

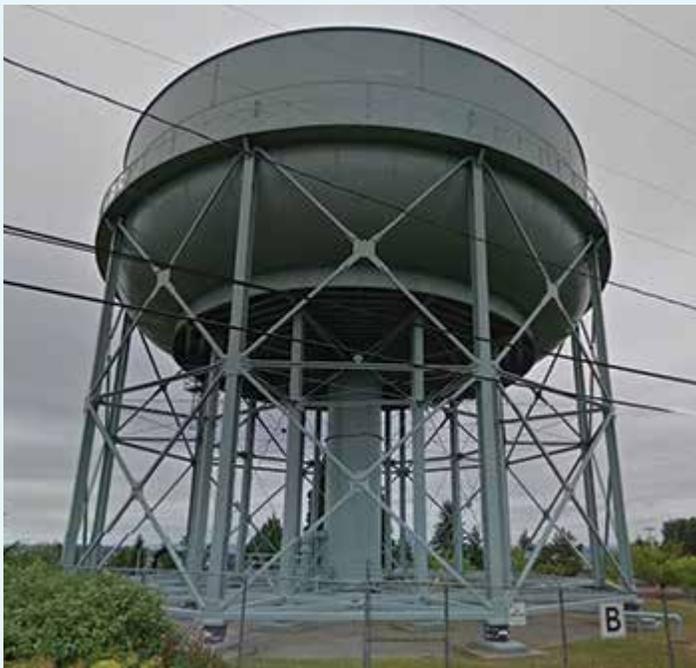
Myrtle Street Water Tank (Photo copyright 2012 Google Maps)

Case Study – Myrtle Street Water Tank - Enclosure of existing bridges, towers and tanks with netting or shrink-wrap, can often result in these structures being exposed to higher wind forces than they were originally designed to sustain. Therefore, a wind monitoring program and enclosure removal plan is regularly developed to ensure that a critical load limit is never exceeded. For the massive steel water tank located in Seattle, WA, the as-built plans were examined, and a complete 3D computer model of the structure was developed in order to determine at what wind speeds the system could remain enclosed. The time and expense to remove and reinstall enclosure or access systems can be extreme, and therefore a careful evaluation of various wind speeds vs. structure and access solutions is important on many jobs.

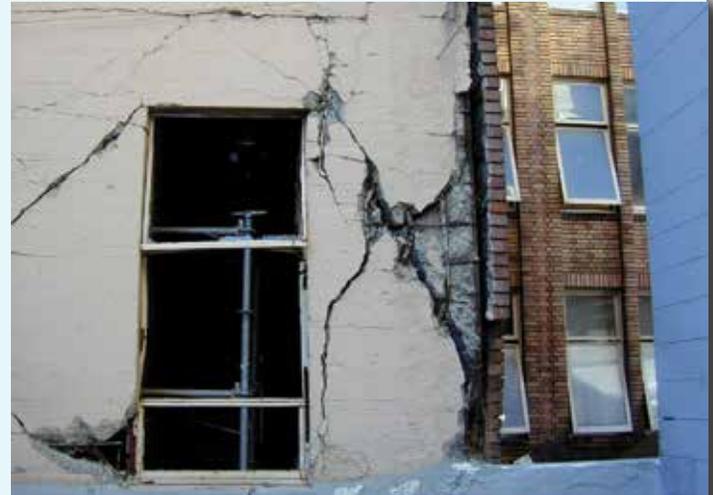
Case Study – Wakefield Building - When this 1920's 5 story reinforced concrete structure was rocked by the 1989 Loma Prieta earthquake, much of its damage remained hidden for many years. It wasn't until significant retrofit work had begun in the basement, that it was discovered that various primary structural support columns were completely shattered. Designing an emergency shoring system capable of supporting all the floors above while columns were cut and replaced at the basement level, required an extensive assessment of the existing structure and careful evaluation of various shoring options. In lieu of a costly custom fabricated steel support system, a dense matrix of relatively light system scaffold was erected. This system was installed on all floor levels, effectively collected the weight of the building and diverted it away from the damaged columns, and allowed the contractor make the cuts and repairs, while using a very cost-effective and locally available resource.

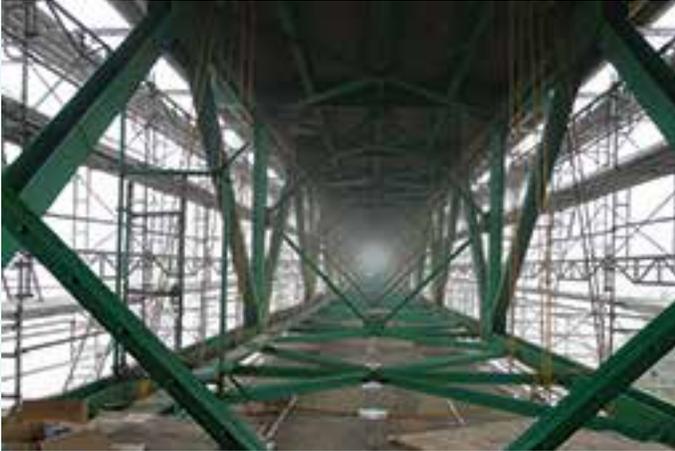
Case Study – Salinas River Bridge – The California Department of Transportation has traditionally required that painting and abatement platforms be designed for a live

load of 45 psf, with an additional concentrated load of 1,000 lb. Using historic inspection reports and performing a supplemental structural analysis, it was determined the existing highway bridge could not support the proposed 45 psf required by the state. Therefore, close coordination with contractor and DOT was necessary in order to develop detailed construction procedures and load monitoring program to ensure loading stayed within the bridge's reserve capacity. In this specific case, the DOT allowed for a load rating of less than that outlined in the specifications, however, this variance has not been consistently approved on all bridges.
