scaffold & access magazine

NEARLY IMPOSSIBLE SHORING

THE 2019 SCAFFOLD & ACCESS INDUSTRY ASSOCIATION (SAIA) SHORING PROJECT OF THE YEAR WENT TO PCI SCAFFOLD'S SEATTLE HEADQUARTERS FOR THE ENHANCED CIRCULATION/ ELEVATOR RELOCATION PROJECT.

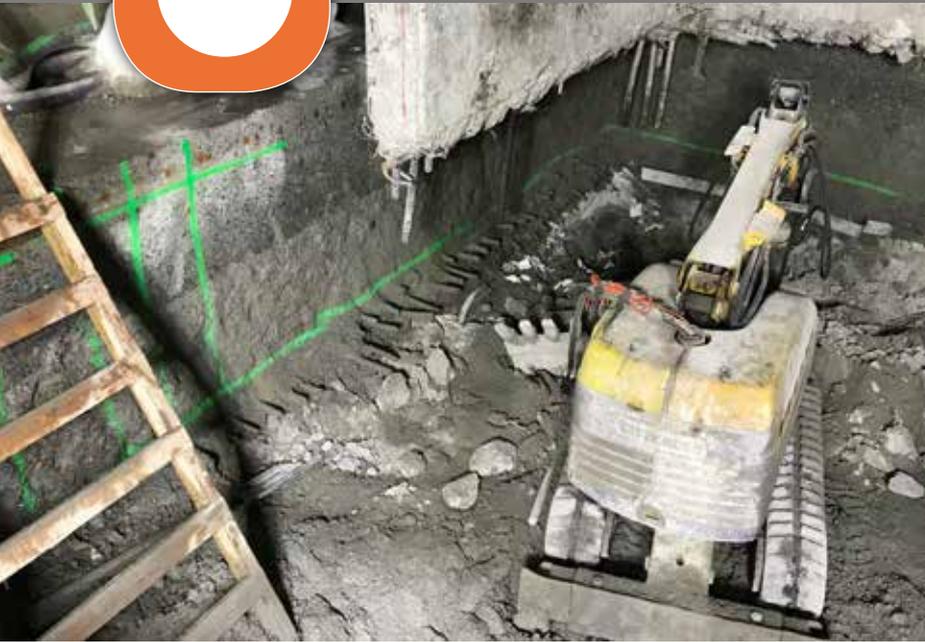
Sub-basement view of the footing for the shear wall removed with the shear wall suspended

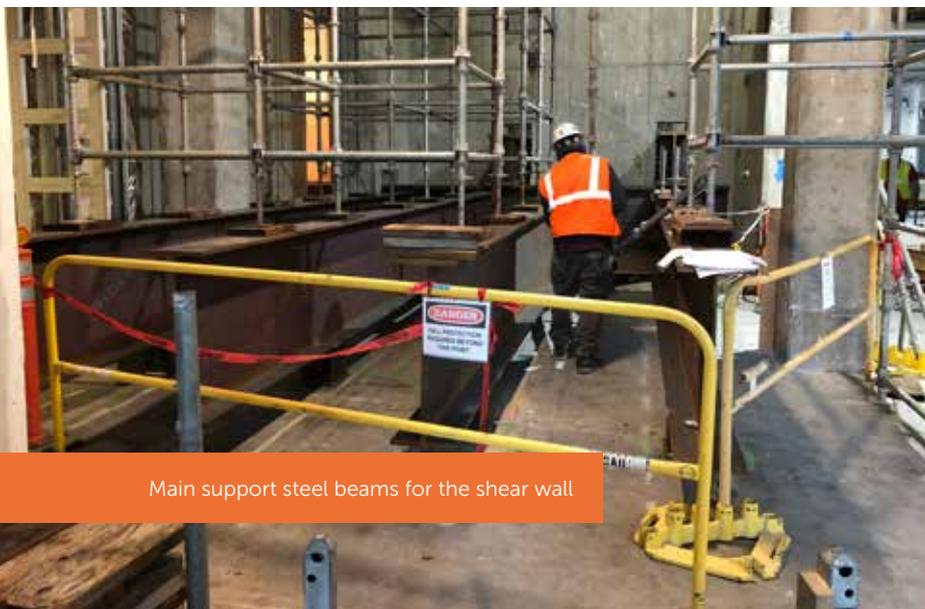
Main support steel beams for the shear wall

Once holes in the wall were cut, the W40x431 beams were rolled into place on Level 1 and passed through the wall. Then the W27x281 beams were set atop the W40x431 beams to support the perpendicular wall. The 1,500,000-pound design loading and the distance of the beam spans caused too much deflection. As a result, staying within the 0.16-inch measurement was not possible. To solve this problem, PCI Scaffold provided cuplock shoring platforms spanning from the basement to the roof, giving support to the shear wall tributary slab loading. With these in place, the W40x431 beams would only need to support the 12-to-18-inch-thick shear wall.

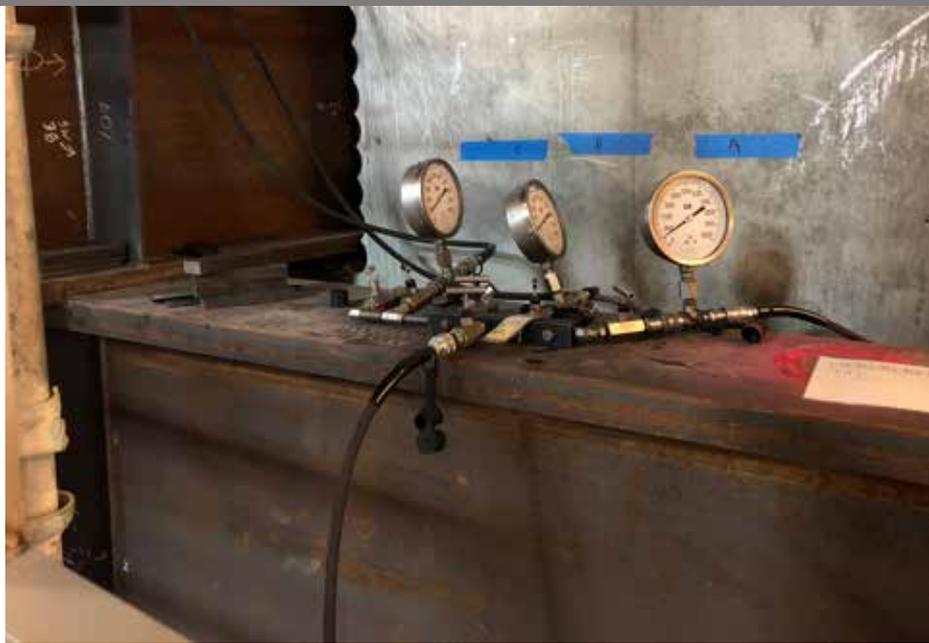
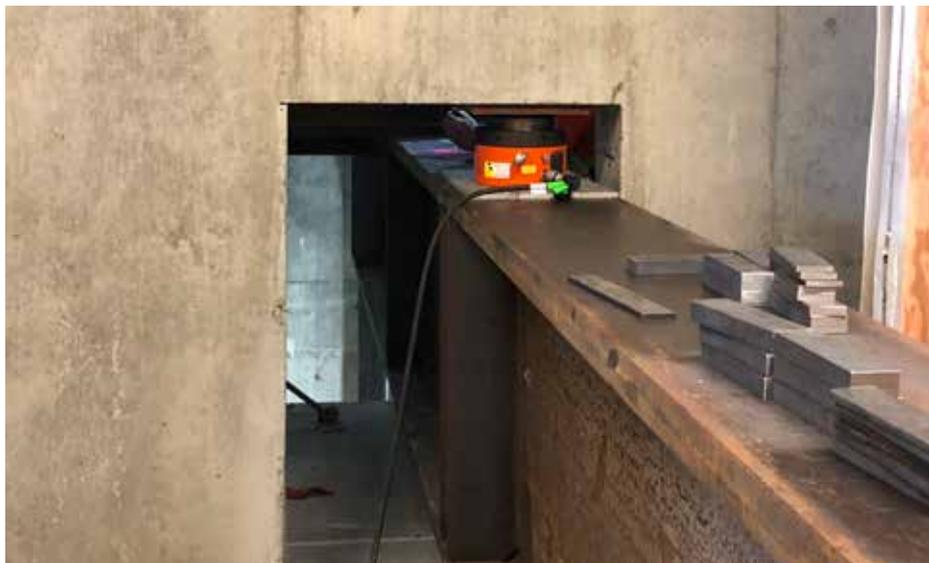
Steel support beams running through the holes cut in the shear wall and resting on the transfer steel beams
